**Inventory and Evaluation of
Engineering Cultural Resources:
Montgomery to Gadsden, Alabama
Coosa River, Alabama**

Prepared for the
U.S. Army, Corps of Engineers
Mobile District
Mobile, Alabama

D. Gregory Jeane, Ph.D.
Department of Geography
Auburn University
Auburn, Alabama

March, 1981

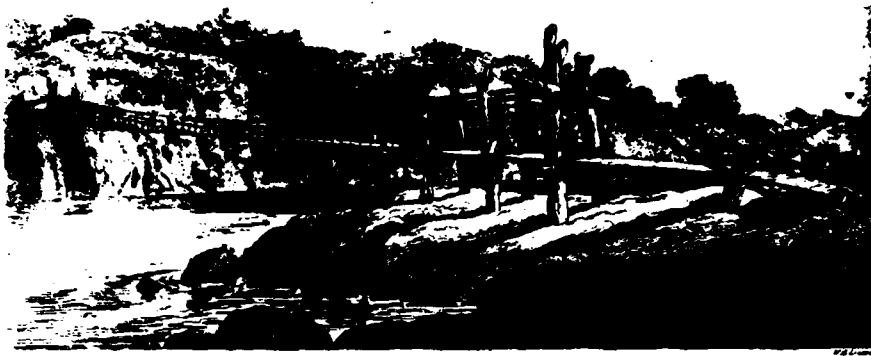
Fig. 1

BRIDGE MADE OF WIDE LOGS OVER THE RIVER MAYPO IN CHILE.

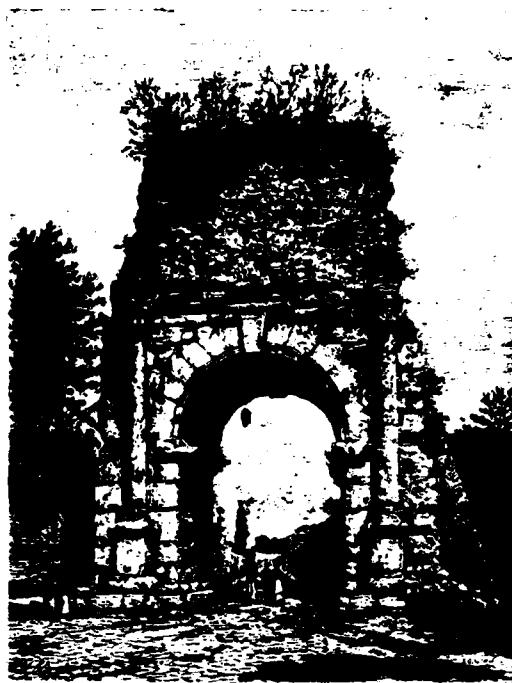
Fig. 3

The building form par excellent of the Roman engineer was the arch (Fig. 3). Where the knowledge of the arch developed simply is not known but it appears that the first architects to come to Rome brought the concept with them from Etruria, an important hearth area for Roman culture in west central Italy near the present states of Tuscany and Umbria.

The construction of a bridge in ancient times, in all times really, posed some difficult questions. What, for example, would form the foundation of the pier? How could materials be secured under water? How would the pier, once built, be protected from scour? The Romans solved all of these problems with the use of the arch. The only arch form

known to them was the semi-circle, a type which rests half of its weight on each of two piers. The Romans built the abutments first and then one pier at a time connecting one arch at a time.

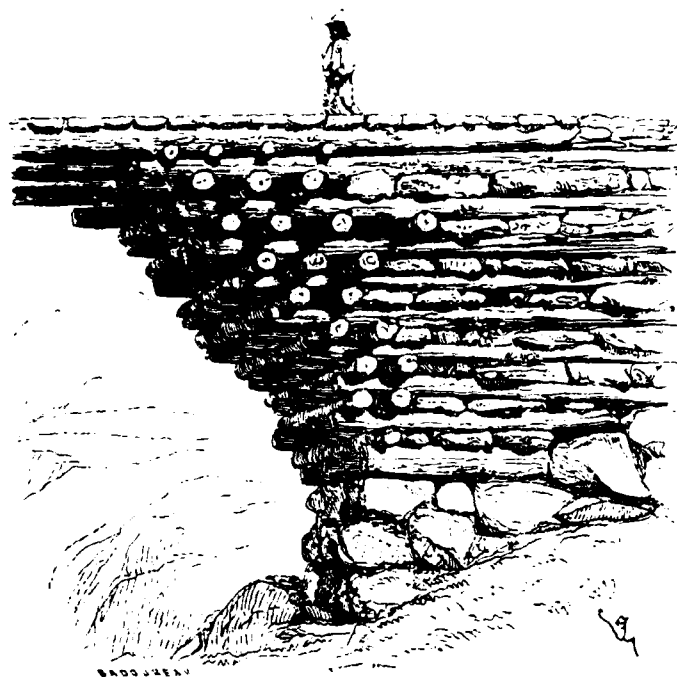
Fig. 11

during the Han period (206 B.C. - 221 A.D.). The Asia bridges appear, however, to have more often been cantilever or suspension types. The Chinese cantilever was a combination of stone and timber (Fig. 11). It was diffused from China to India where elaborate structures were built in Kashmir. Robin (1948:94-97) claims that the type is found in Africa, China, even in alpine Europe, but the best examples are found in the Himalayas. Chronology of bridges in Asia is not established with much certainty and it is not possible to positively state if the movement of the technique was from central Asia to the periphery or vice versa. Substantially built examples of the cantilever bridge are known in Tibet and Nepal.

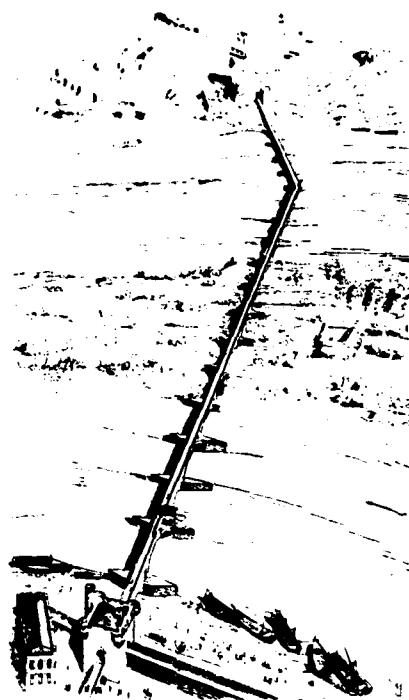
Fig. 13

Among the many bridges built in the medieval period, the accepted engineering triumph was the Pont d'Avignon (Fig. 13). It was the longest bridge built since Roman times, nearly 3000 feet, and remained the longest bridge in the world for a considerable time. Aqueducts excepted, it was the longest stone-masonry bridge ever built. A number of changes in construction technique are apparent in this bridge. One of its most striking features is the sharp upstream angle (thirty degrees) of the section across the main channel of the Rhone. The Rhone is a particularly treacherous river and subject to severe floods in historical times. Petit-Benoit, the builder, incorporated the use of an elliptical arch rather than the semi-circular. This reduced the necessity for massive piers and resulted in higher arches. This was a significant engineering advance in that it led toward producing a clearer waterway and therefore a bridge more secure against flood (Gies, 1963:30). The bridge stood against warfare and flood until, in 1602, a major flood collapsed an arch.

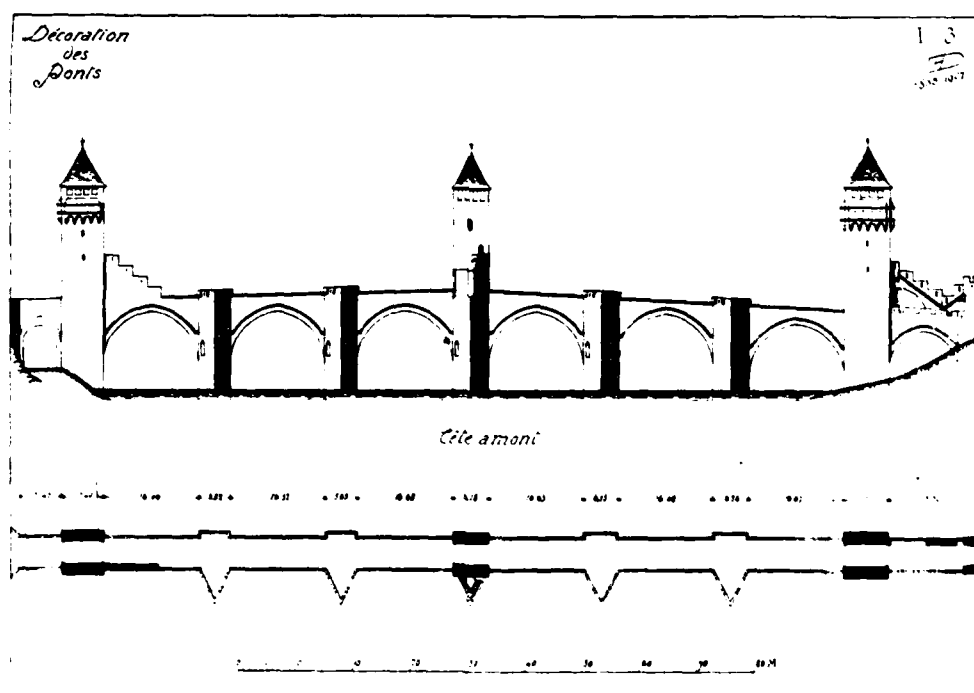
Fig. 14

Another feature of medieval bridges was fortification. Considering the nature of social and political conditions, many bridges were built with tall towers suitable for firing down upon boats on the river or troops on land. The Pont de Valentre at Cahors, France, (Fig. 14) is one such bridge. It is one of the finest and most complete fourteenth century bridges with its crenated piers and three tall towers. According to Whitney (1929:89) it has the "aspect of a well-disciplined warrior."

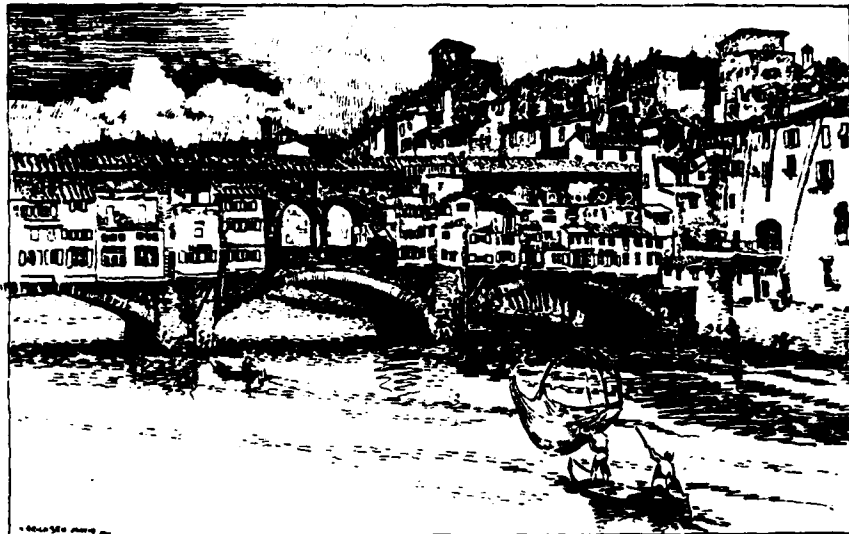
Fig. 15

Another well-known bridge of the medieval period in the Ponte Vecchio (Fig. 15) over the Arno River in Florence, Italy, built in 1345. This is one of the earliest bridges with arches in the form of flat circular arcs, a form reminiscent of modern stone arches.

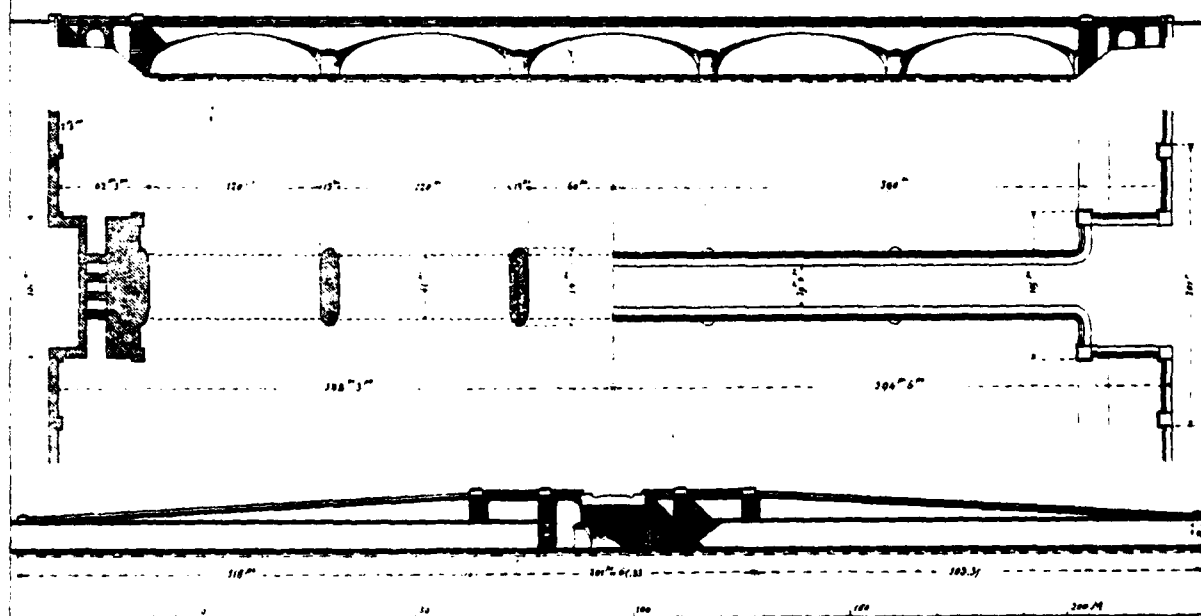
Fig. 22

Another development by Perronet, that became more popular in the nineteenth century, was a significant reduction in the size, i.e. width, of the pier. Piers became much smaller in proportion to the span of the arch (Fig. 22). His last and most important work was the Pont de la Concorde in Paris (Fig. 23). Although he was recognized as the foremost bridge authority of his day, the design was too radical and not accepted as submitted. He made a number of changes but was able to persuade authorities to keep the piers narrow, thus allowing the bridge to retain some of its aesthetic quality.

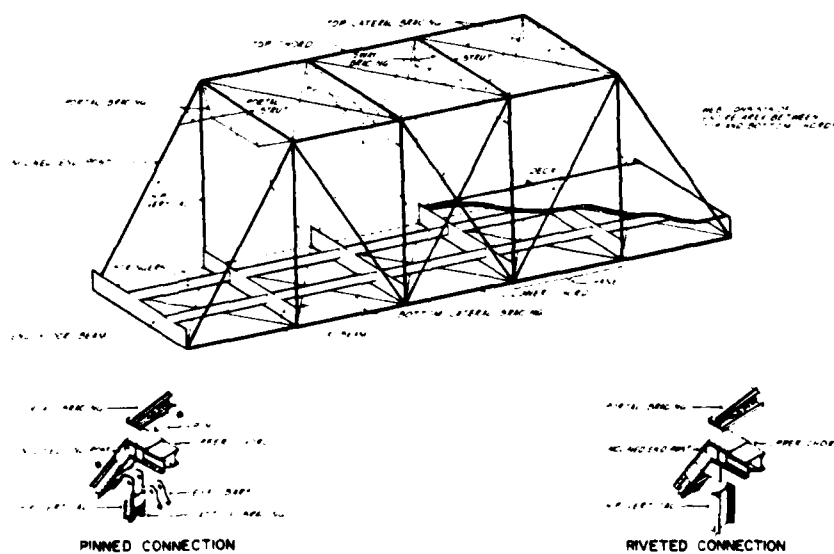
Fig. 26

invented. It is from the evolution of bridge technology that we get such types as the Pratt and Warren trusses. Most of the metal trusses in America were one of the above or a variation on the form (Comp and Jackson, 1977:no pagination). Both forms date from the 1840s and were used so extensively that their versatility, durability, and economic desirability made them popular until well into the twentieth century. Most of the bridges over the Coosa River are a variation of these forms (Fig. 26).

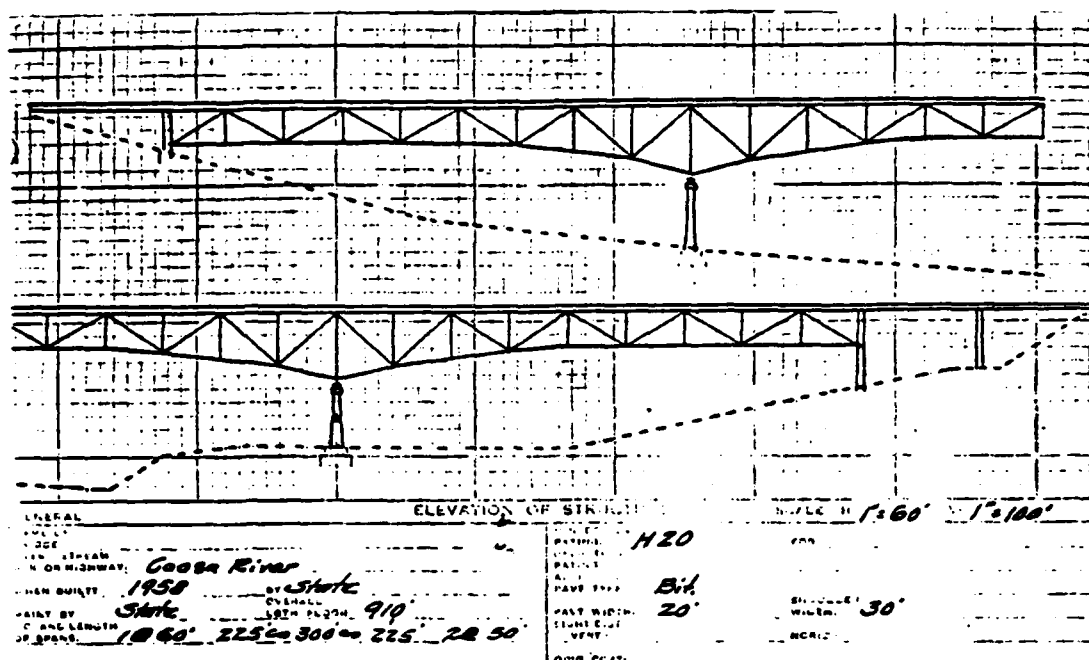
Fig. 27

Alabama Highway 22 below Mitchell Dam

This bridge, built in 1958 by the State of Alabama over the Coosa River just south of Mitchell Dam, consists of I-beam and truss spans for a total length of 910 feet. It was built to improve crossing of the river. The road straightened somewhat before bridge construction and generally improved connection of east central Alabama with the Black Belt region. Prior to construction of this bridge there was a toll ferry just south of the bridgehead. Alabama highway 22 was graded and drained in 1930 and the old section down to the ferry was paved in 1948. The old ferry landing on the east bank is now private property; on the west bank it is used as a public boat ramp.

The recent construction date, lack of appreciable historic significance, and typicality of design does not make this bridge particularly significant as an engineering resource. For these reasons I would not recommend this bridge be considered eligible for nomination to the National Register.

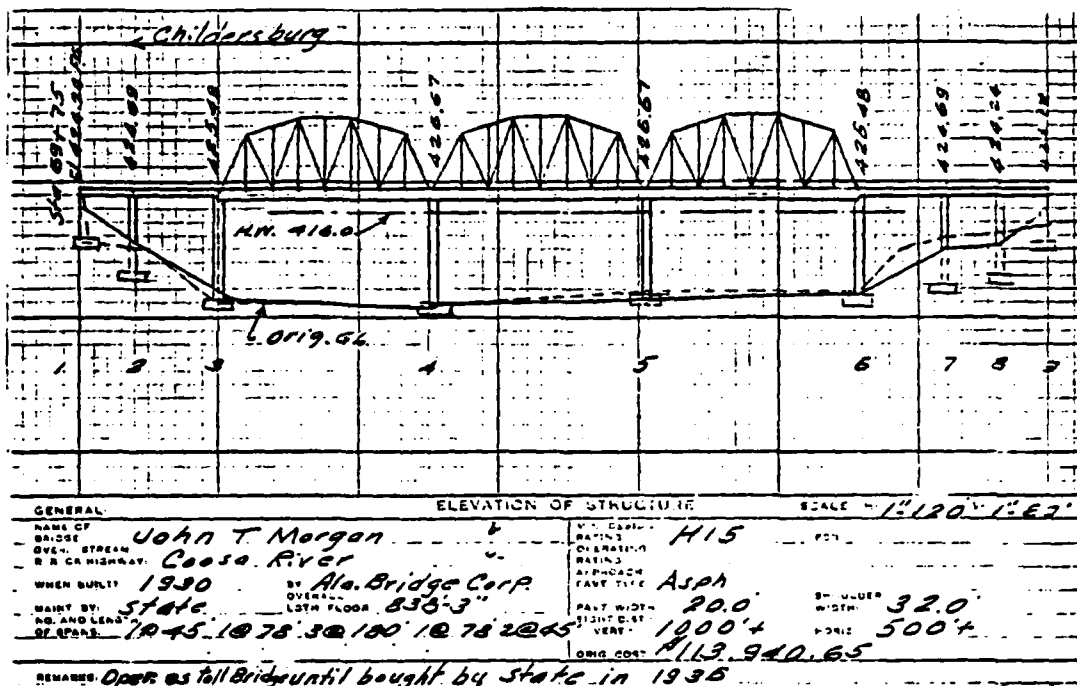
Fig. 28

U. S. Highways 280 and 231 at Childersburg

This bridge was built in 1930 by the Alabama Bridge Corporation at a cost of \$113,940.65. It was operated as a toll bridge until it was bought by the state in 1936. It is one of a number of bridges authorized by the State Legislative Act of 1927. There was a desire for and need to link the highway systems to improve development of the state's economy; these toll bridges figured importantly in the overall scheme. This particular bridge was part of the effort to improve the Florida Short Route (portions of U. S. Highways 78, 231, and 280). The bridge spans the Coosa River at Childersburg and was dedicated June 12, 1930, to the memory of John Tyler Morgan, a distinguished Alabama citizen and U. S. Senator. It connects Talladega and Shelby counties and covers a length of 838 feet, 3 inches. Prior to construction of the bridge, a ferry site south of the bridgehead handled traffic. The ferry itself operated for nearly a century.

The most significant historical association of this bridge is its past role as a toll bridge and one of the bridges authorized by the legislature in 1927 to link the state's highway systems. In addition to its significance as a link in the state's highway systems, and thus a broader significance as an important innovation in improving intra- as well as interstate communication, the bridge incorporates the distinctive characteristics of a recognized bridge type (Warren truss). For these reasons the bridge is considered eligible for the National Register.

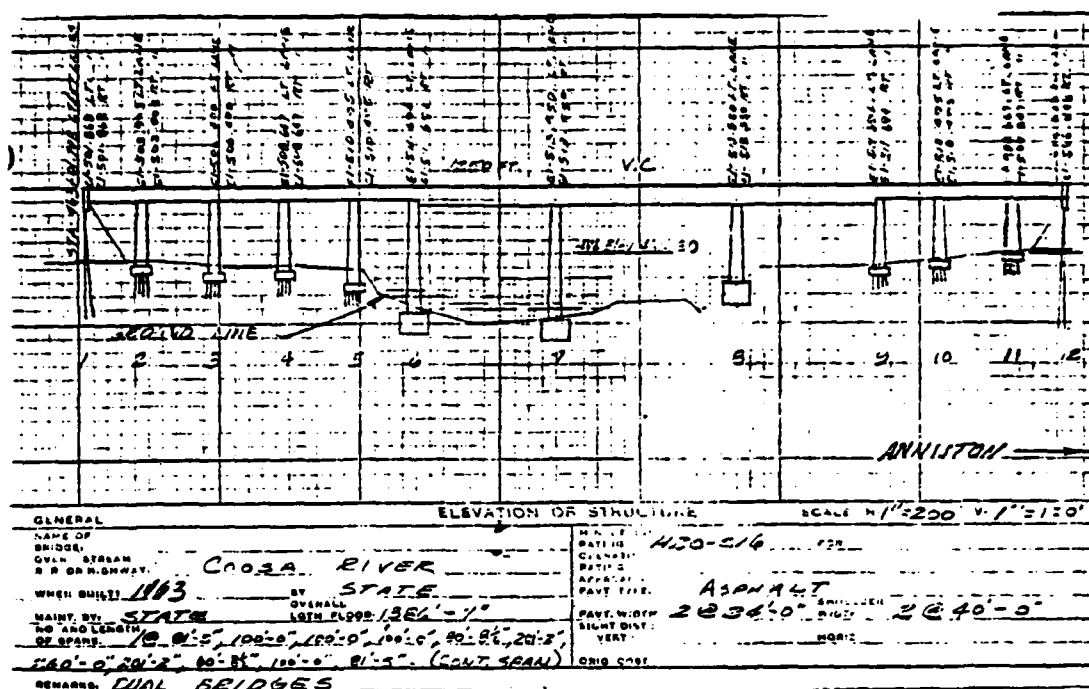
Fig. 29

Interstate 20 east of Pell City

This is a set of dual bridges across the Coosa River east of Pell City. The bridges are steel I-beam and girder designs with a total span each of 1386 feet. The bridges were constructed in 1963 by the state as part of the Federal interstate system. The recent construction date and standard design of these bridges do not make them eligible for the National Register and thus they are not recommended.

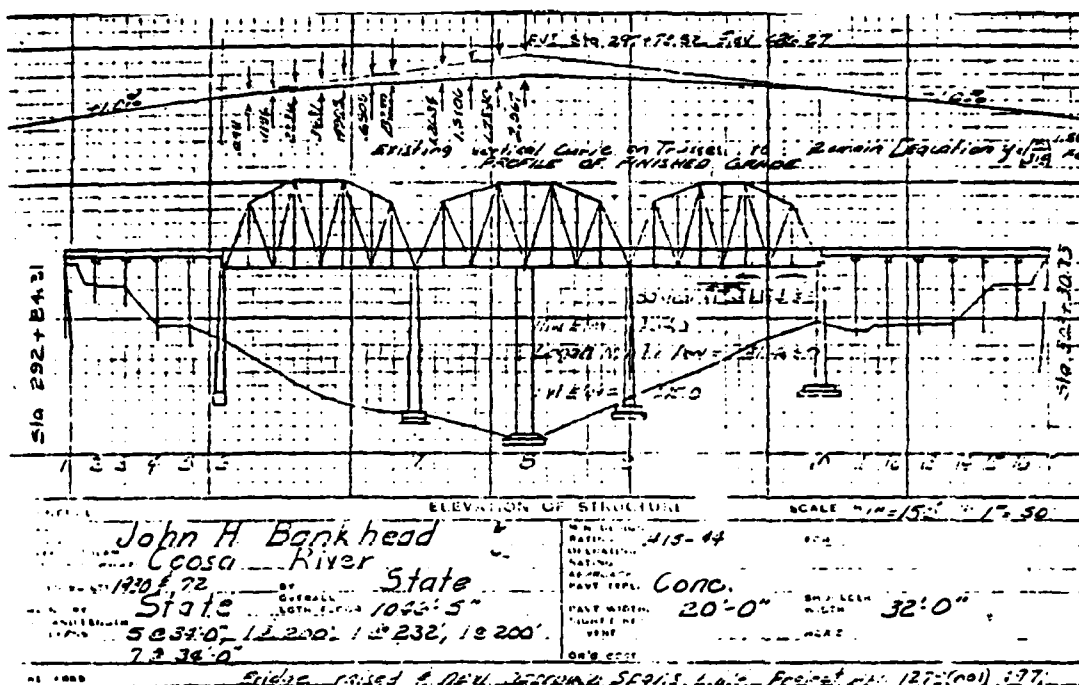
Fig. 30

U. S. Highway 78 east of Pell City

Another of the bridges built in the early part of this century as a consequence of the Legislative Act of 1927, this bridge is locally known as the John H. Bankhead Bridge. It was dedicated on April 18, 1930, in a ceremony honoring U. S. Senator John Hollis Bankhead. The bridge has historical significance in that it crosses the Coosa River on the transcontinental highway named in honor of the senator; Bankhead was a prominent national supporter of Federal aid to construct good roads. The bridge was constructed by the Vincennes Bridge Company and presented to the Alabama Bridge Corporation upon completion.

The bridge is a steel riveted Warren thru truss design with a camelback shape. The bridge was raised in 1971 and new approach spans were constructed. There are twelve approach spans of thirty-four feet each (five on the west and seven on the east). The truss spans are 200 feet, 232 feet, and 200 feet. The larger of the truss spans is in the center and is an inoperable swing span. The total length of the bridge is approximately 1040 feet. The bridge has been damaged from excessive use and oversized loads. The concrete on the main piers is disintegrating, and disintegration is evident on caps, girders, handrails, and the deck girders. In addition there has been damage from collisions to various members of the truss spans.

The Bankhead Bridge is part of a transcontinental route that runs from Charleston to Memphis, a route known as The Bankhead Highway. There is greater historical than engineering value to the bridge, but it is one of the few swing bridges on the Coosa, albeit inoperable presently. Because of its age, its association with Senator Bankhead, and as a former swing bridge, I recommend this bridge be considered eligible for nomination to the National Register.

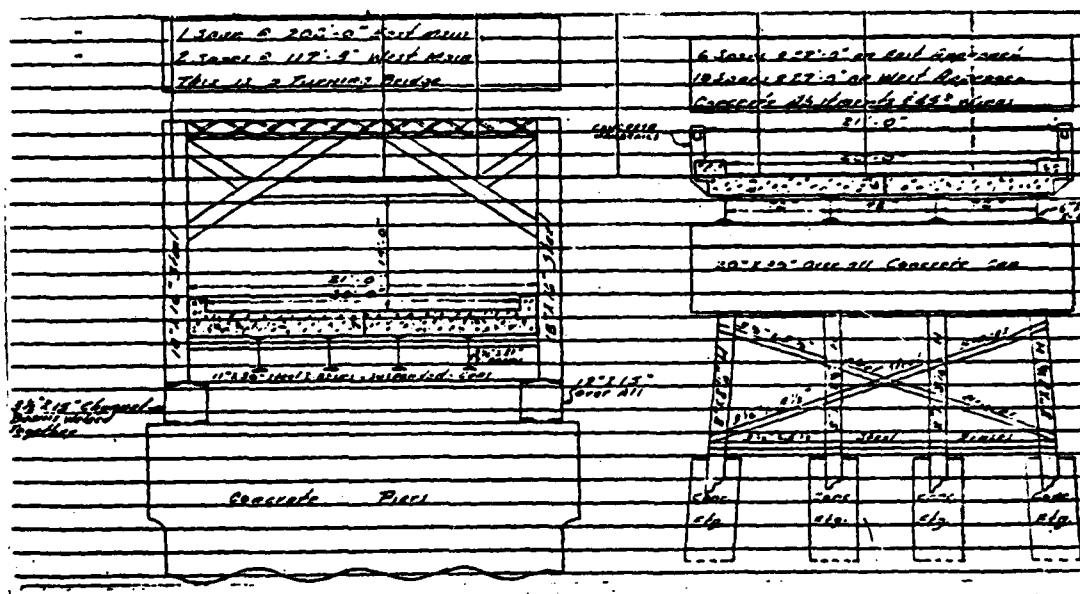
Fig. 31

Old Alabama highway 77 south of Gadsden

This bridge, known as the Gilbert's Ferry Bridge, was constructed in 1939 as part of the Works Progress Administration and serves as part of the state's highway network between Lafayette and Gadsden. It is a steel riveted, Warren thru truss design exactly like the Bankhead bridge on U. S. Highway 78. It consists of 16 approach spans of twenty-seven feet each and three truss spans of 117 feet, 3 inches; 202 feet; and 117 feet, 3 inches. The center section is an inoperable swing span. The bridge is in good condition despite heavy use.

This is one of the few concrete arch bridges still standing in the state and only one of two on the Coosa in Alabama. It is an important engineering resource by virtue of its being an example, and an excellent one too, of a major building medium of the early twentieth century. It has value therefore from both an architectural, historical, and engineering point of view and the bridge is recommended for consideration by the National Register.

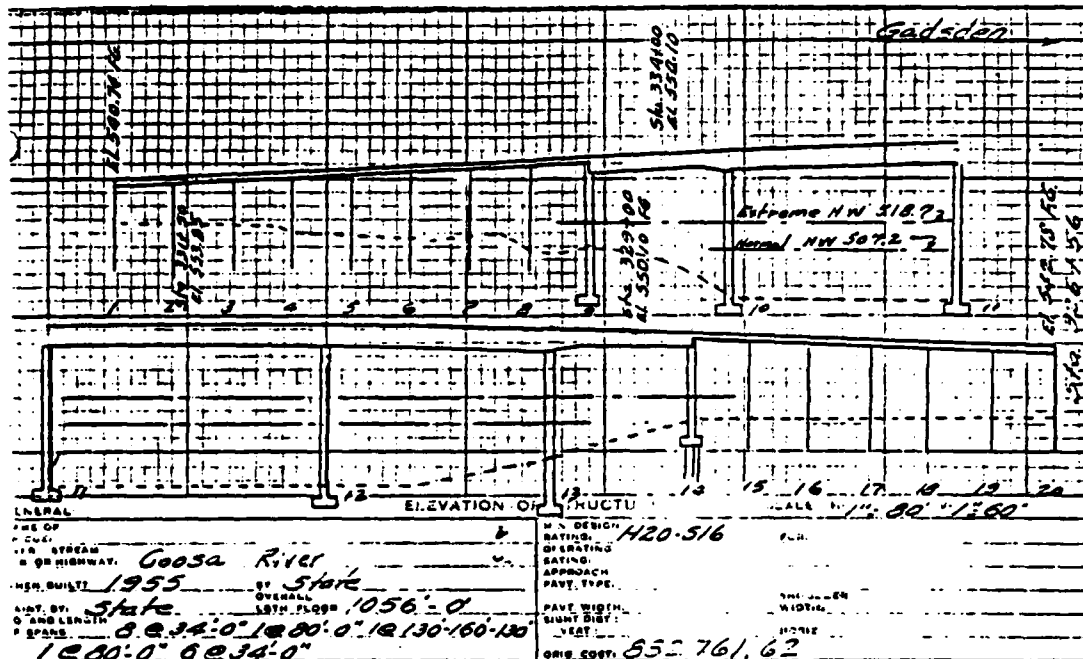
Fig. 33

New U. S. 431 and 278 at Gadsden

This is a relatively new bridge constructed by the state in 1955 to reroute heavy traffic from the downtown area. It is a concrete and plate girder bridge north of the old concrete arch bridge and has an overall length of 1056 feet. It consists of fourteen concrete approach spans of thirty-four feet each and five plate girder spans ranging from eighty feet to 160 feet.

This bridge has no historical or engineering significance and is not recommended for consideration by the National Register.

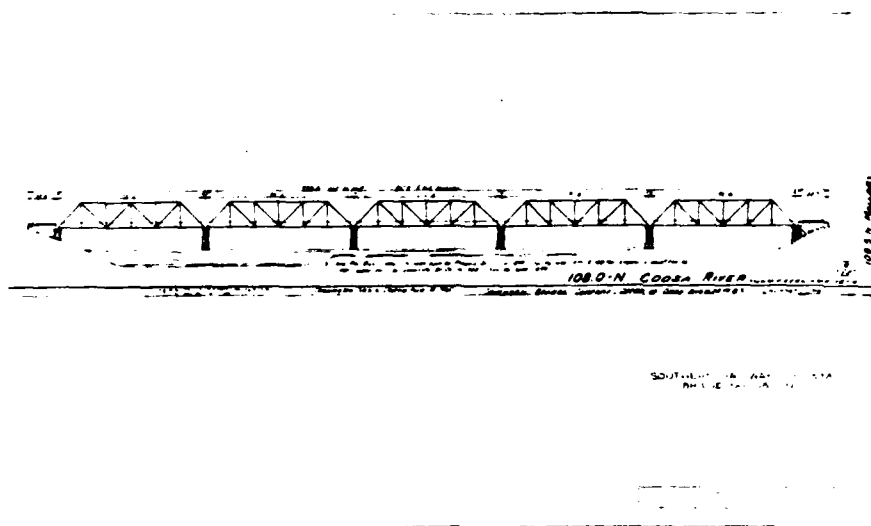
Fig. 34

Southern Railway system just south of Childersburg

This five span bridge crossing the Coosa just south of Childersburg is owned by the Southern Railway Company. It consists of one 172 foot span and four 170 foot spans; the overall length of the bridge is 933.3 feet. The eastern most span, a Warren truss, of 170 feet was built by the Phenix Bridge Company in 1902. The bridge is mostly a Pratt thru truss design that is pin-connected rather than riveted. The piers are of stone and the bridge is apparently in good condition despite long use.

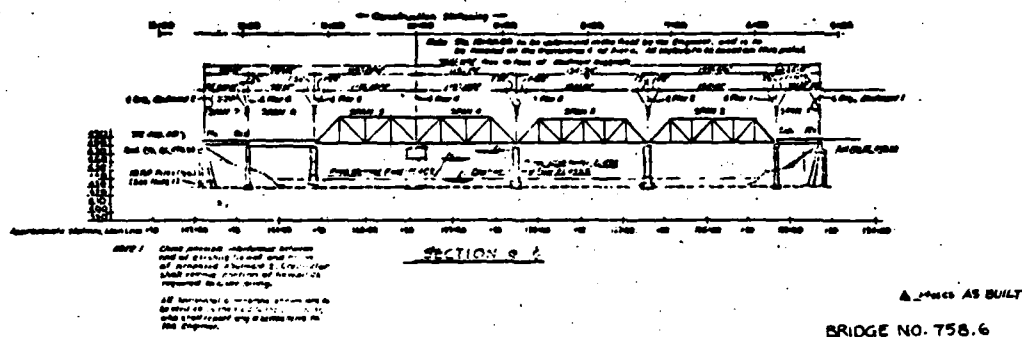
Fig. 37

Southern Railway System bridge east of Pell City

This important bridge over the Coosa at Riverside, Alabama, is part of the Atlanta to Birmingham route owned by Southern Railways. The crossing consists of a 228 foot Warren thru truss swing assembly, two fixed-pen Warren thru truss spans of 154 and 152 feet respectively. There are additional deck trusses to give a total length of 725 feet, 11 inches. The original girder and truss spans are said to have been built in 1896. The bridge plate on the operable swing span has the Virginia Iron and Steel Company of Roanoke, Virginia, and the date 1927.

This is a significant bridge from an engineering viewpoint. It meets the age criterion for the National Register. It is pin-connected rather than riveted and is an operable swing bridge. In addition, it is adjacent, within a few hundred yards, of the John H. Bankhead Bridge, a historically significant highway crossing. In addition, this is the only Warren thru truss bridge between Martin Dam and Gadsden, Alabama. For these reasons, we recommend that this bridge be considered for nomination to the National Register.

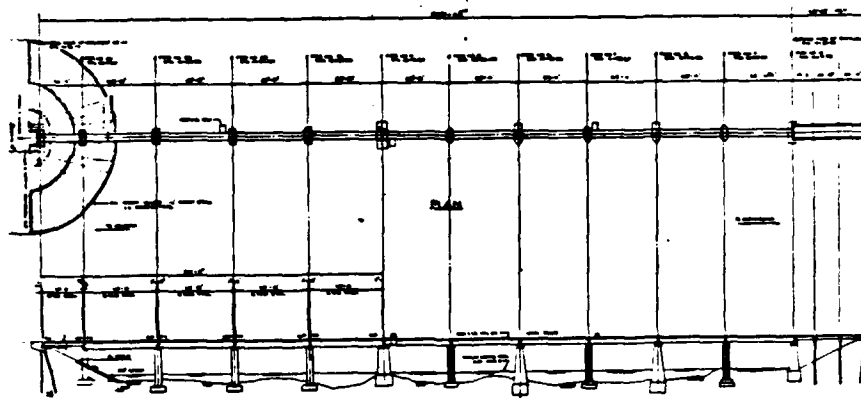
Fig. 38

Seaboard Coast Line Railroad below Neely Henry Dam

This bridge, originally built in 1882, has been reconstructed in its entirety between 1974 and 1976. It consists of a series of open deck spans making a total length of 695 feet. The only original work remaining is several of the stone masonry piers. Because information is not available, we have no knowledge about what type of bridge was originally on this site, who constructed it, or any other pertinent data except that it consisted of a truss swing span and fixed truss spans. Not enough information is available to determine eligibility; therefore, it is recommended that this bridge not be considered by the National Register.

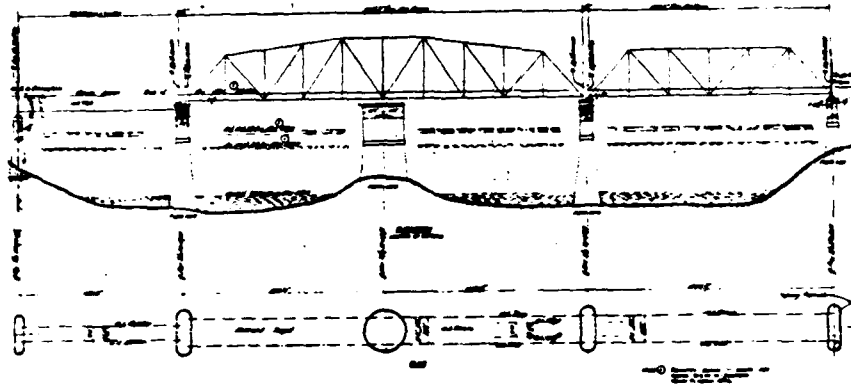
Fig. 39

Louisville and Nashville Railroad at Gadsden

This important bridge across the Coosa at Gadsden, Alabama, is owned by the Louisville and Nashville Railroad, a division of The Family Lines Rail System and is designated as part of the Alabama Mineral Division, perhaps an indication of its importance as a freight line. The bridge has a total length of approximately 1913 feet, 2 inches. The timber trestle approach on the end nearest Calera, Alabama, (the east) is approximately 1135 feet, 4 inches long. It was originally built in 1911 and rebuilt in 1943. The main spans were constructed in 1909 by the American Bridge Company and consist of a 147 foot, 6 inch Pratt thru truss, a 244 foot, 7 inch Pratt thru truss swing span, and a 98 foot steel deck girder. The timber trestle on the western, or Gadsden approach, is approximately 281 feet, 10 inches long and was originally built in 1911, rebuilt in 1944. No determination has been made on the operability of the swing span.

to Gadsden. The fact that it served as both a highway and railroad bridge before construction of the Etowah Memorial Bridge, its long wooden trestle, and its status as a swing bridge make this a significant engineering resource. As such I recommend that it be considered by the National Register.

- c) the Louisville and Nashville bridge no. 149 at Gadsden - This bridge is representative of the use of swing truss assemblies in aiding navigation on American rivers. In addition the bridge is important historically because it served as both a highway, railway and pedestrian crossing of the Coosa until the Etowah Memorial Bridge was constructed in 1927. It also has the longest wooden approach trestle of any bridge on the Coosa between Montgomery and Alabama; most wooden trestles have long since been replaced by concrete approach spans. I recommend that it be mitigated through complete historic and photographic documentation.

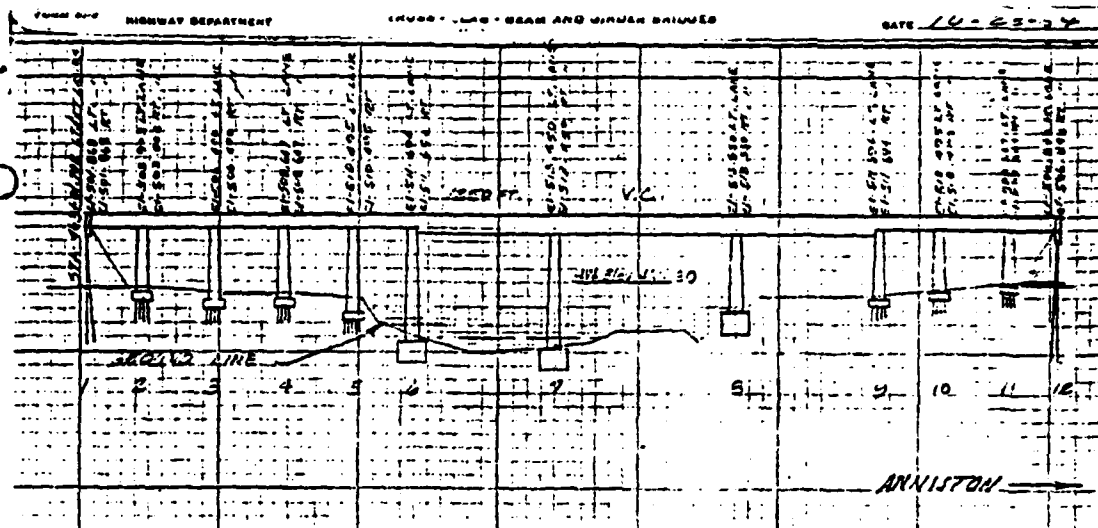
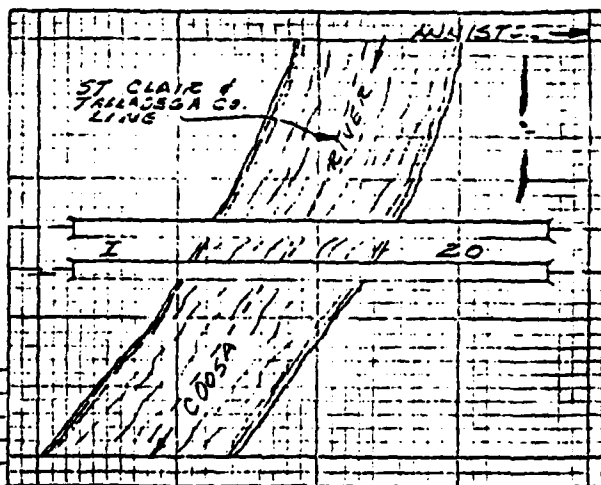
GENERAL ELEVATION OF STRUCTURE SCALE H¹/V¹ = 200

GENERAL CONDITION Truss spans Fair Deck Girder spans poor

6. CONDITION OF THE MAIN MEMBERS (TRUSSES, GIRDERS, BEAMS, ARCHES): Bent and distorted, Rusted and Corroded in spots.

9. PAINT AND CONDITION OF PAINT WHEN APPLIED? Faint is poor, Do not know when applied.

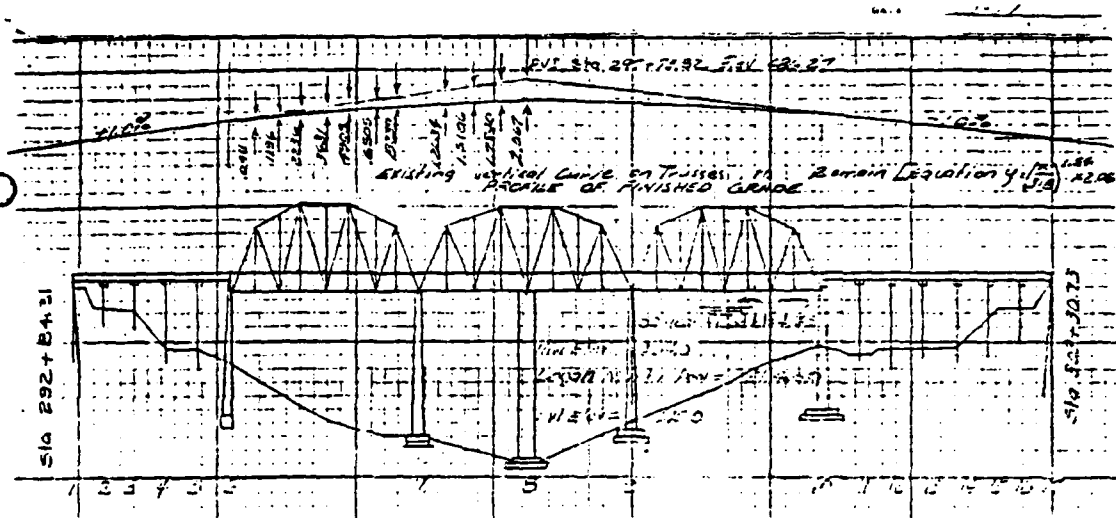
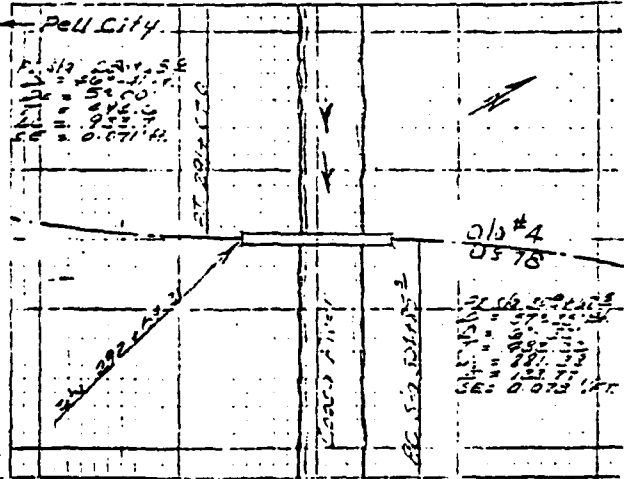
ELEVATION OF STRUCTURE
SCALE 1"=15' 1"=50'

John H. Bankhead
Coosa River State
1930-72
State
5834.0, 12.220, 12.232, 12.200
7.2 34.0

Bridge raised & new approach spans built. Project No. 127 (rd) 1971

16. DESCRIBE IN DETAIL ANY UNSATISFACTORY CONDITIONS LISTED ABOVE? Good except cap Bent No. 14. See attached sketch.

17. HAS THE STRUCTURE BEEN DAMAGED BY COLLISION, OVERLOADING OR OTHER CAUSE? Yes DESCRIBE DAMAGE See Item No. 4 above
 18. HAS THE SUPERSTRUCTURE MOVED TRANSVERSELY? No DESCRIBE

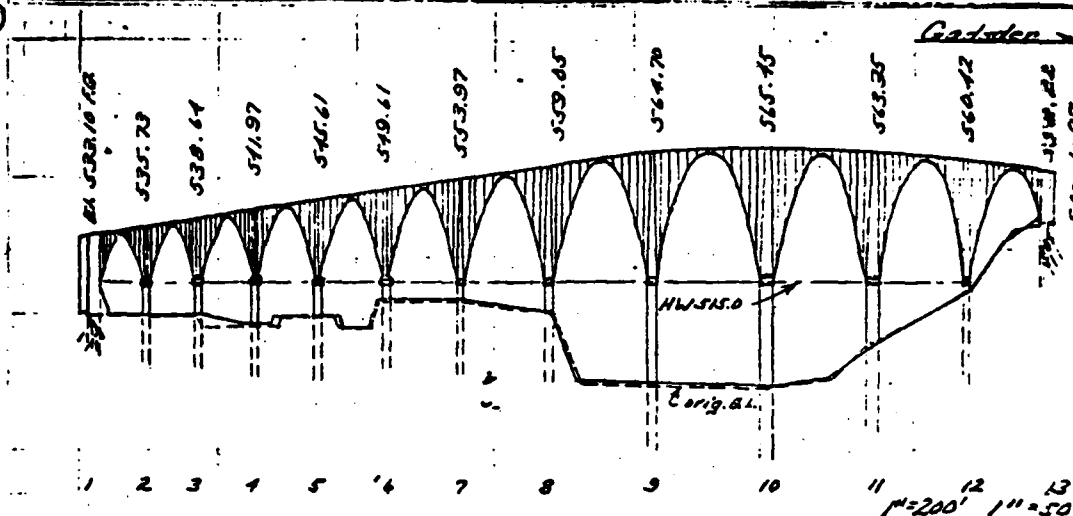
Coosa River
1927
State (C.G. Kershaw Const. Co.)
Concrete
28.0'
500'
3399, 640.30

State
1039'-10126'-10136'-10151'-10136'
10116'-10118'-1022'-1028'-1074'-1066'-1062'

10.0'
580'±
